# CASE STUDY

## ALABAMA MOTOR SHOP PREVENTS POTENTIAL CATASTROPHIC DC MOTOR FAILURE USING PdMA BAR-TO-BAR TESTER

by *Richard Love, RLA, Inc.*

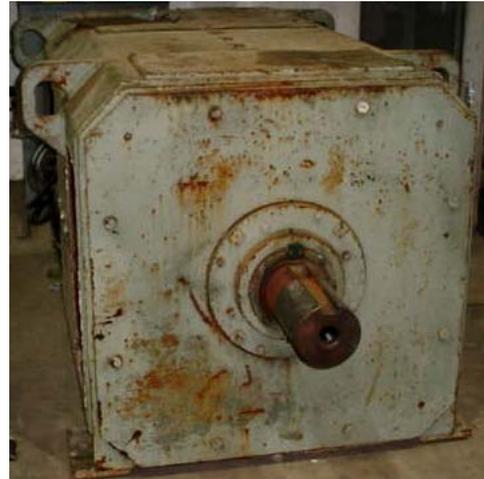
700 HP DC MOTOR

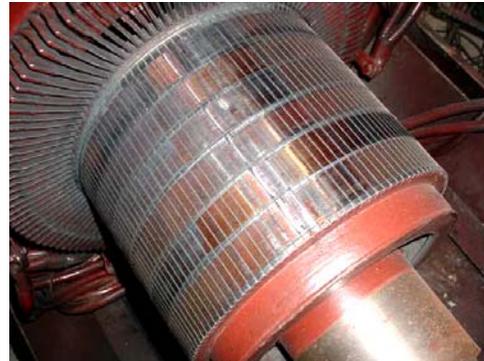
During bar-to-bar testing the armature winding revealed varying resistance measurements that were considered suspect by the repair technician. Although the shop's conventional bar-to-bar tester did not indicate a problem with the armature, the MCE bar-to-bar tester revealed varying high resistance conditions in the armature. After discussing the test data and suspect condition with the customer the decision was made to remove the old armature winding and isolate the problem. While stripping the armature the high-risers came out of the bars - pointing to the reason for the high-resistance readings. The loose risers were most probably causing brush sparking and unacceptable commutator wear.

ARMATURE WITH HIGH-RISERS

After stripping the armature and cleaning the commutator, testing was performed on the commutator to ensure its suitability for rewind. The commutator was tested for grounds, shorts between bars, and commutator bar stability. The commutator was proven acceptable for rewinding and new risers were installed. New armature coils were made, inserted, connected, tested, and VPI treated. The images below show the commutator less the failed risers and the completed armature rewind.

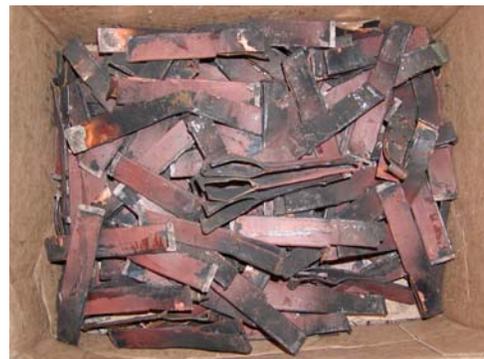
FAILED HIGH-RISERS

If missed during the repair process, the armature might have experienced a catastrophic failure due to flying parts (high-risers) damaging the armature and field windings, as well as destroying the commutator and other internal motor parts.

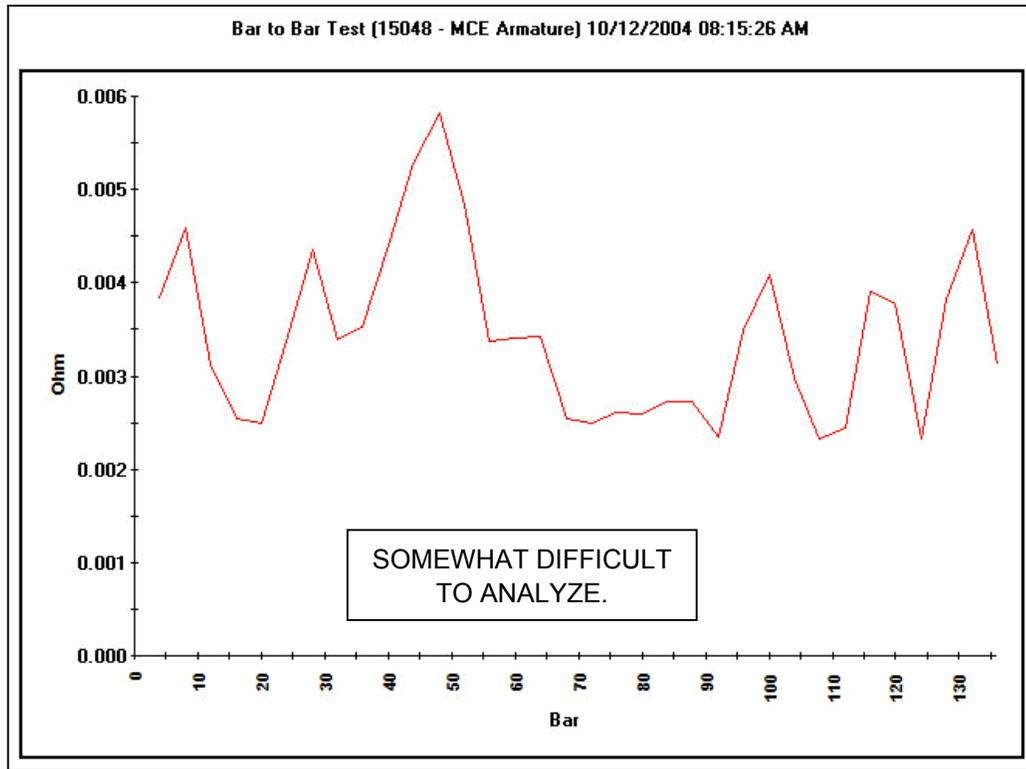
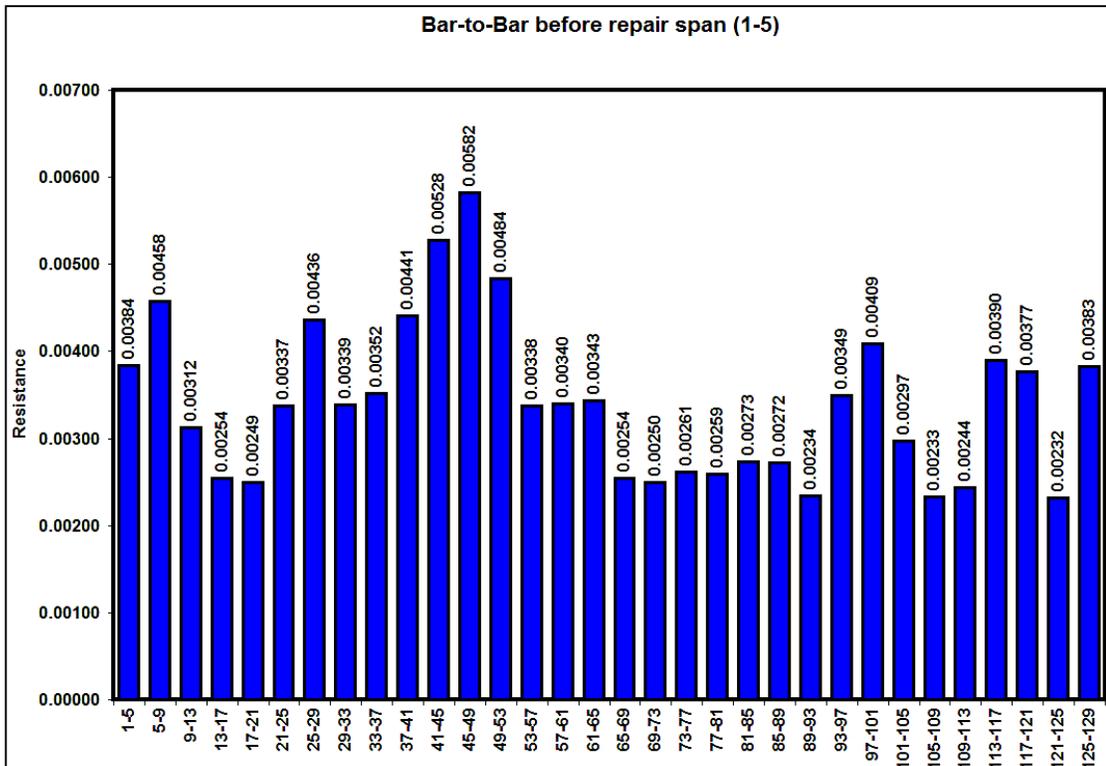
## CASE STUDY TEST DATA – BAR-TO-BAR (BEFORE REWIND)

CONVERT MCE RAW DATA TO EXCEL BAR CHART

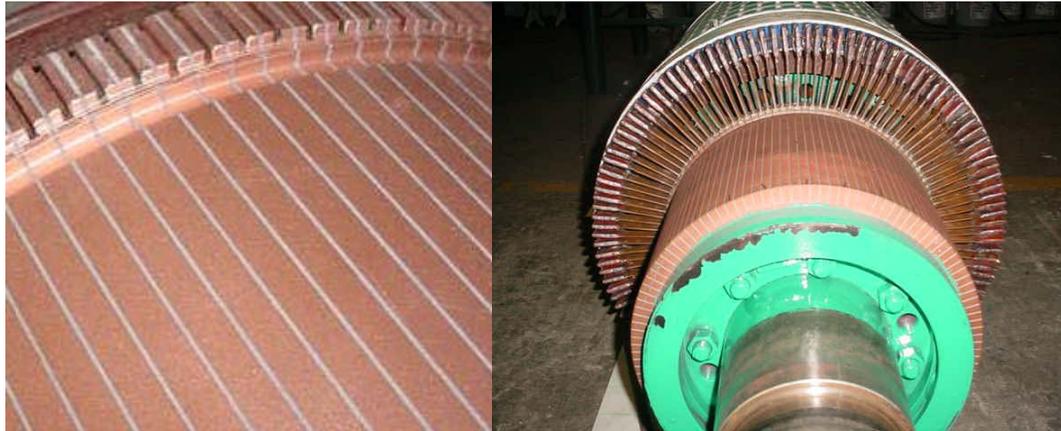
COMMUATOR LESS FAILED RISERS

COMPLETED ARMATURE REWIND

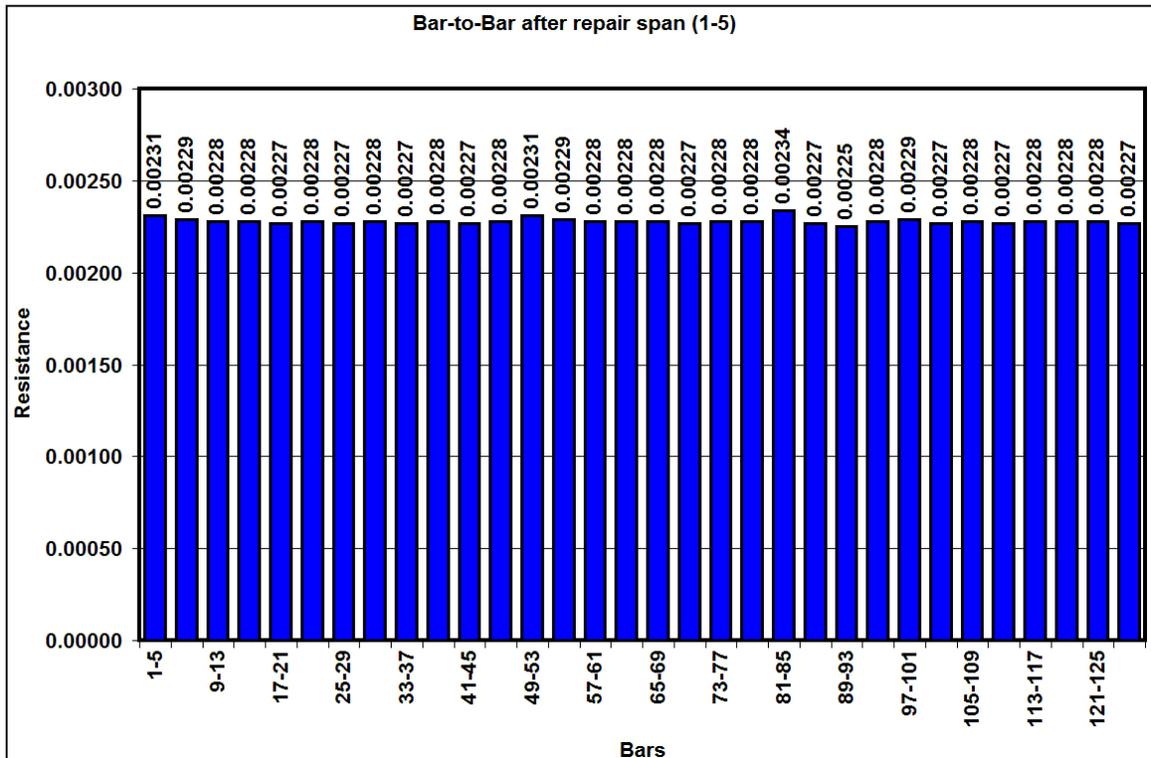
MCE BAR-TO-BAR DATA (AFTER REWINDING ARMATURE)
