# CASE STUDY—ROTOR

## EMAX diagnoses broken rotor bars in 2 pole motor

Industry:	Electric Utility	Fault Zone:	Rotor
Motor Type:	AC Induction	Voltage:	4160
HP:	3500	Speed:	3590 rpm

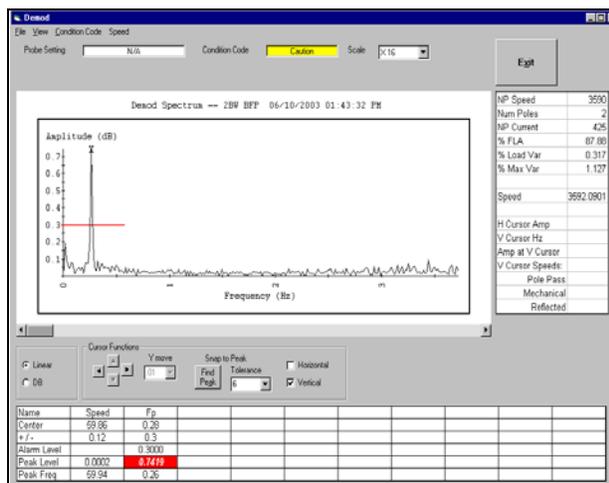
Figure 1

Florida Power & Light Company (FPL) is an electric utility company based in Juno Beach, Florida. During routine EMAX testing in June 2003, Motor Engineer Enrique Rodriguez observed that the peak level of the pole pass sideband was 0.7419, which exceeded the alarm set point of 0.3 (Figure 1). Rotor bar problems were suspected, however, when vibration analysis was performed the results indicated a healthy motor. Due to the conflicting indications between the EMAX and vibration tests, the decision was made to monitor the motor and trend the test results.

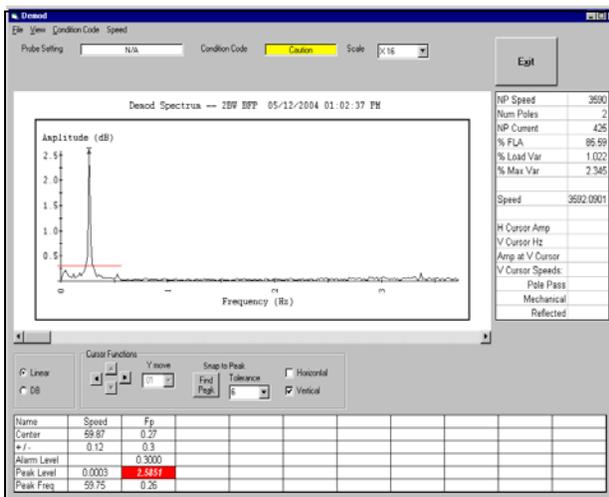
Figure 2

The motor was retested periodically until 5/12/2004, at that time it was removed from service. The trended data indicated a 1420% increase in the peak level of the pole pass sideband from 0.1814 at a running speed of 3591 on 8/15/2001 to 2.5851 at a running speed of 3592 on 5/12/2004 (Figure 2).

Trending the data from tests taken between 2001 and 2004 showed an exponential increase in the pole pass peak levels, which is typically indicative of at least one or more broken rotor bars.

Additionally, there was a 275% increase in the load variation, from 0.855% in 2001 to 2.345% on 5/12/2004 (Figure 2). The load variation should be constant from test to test under normal operating and motor conditions.

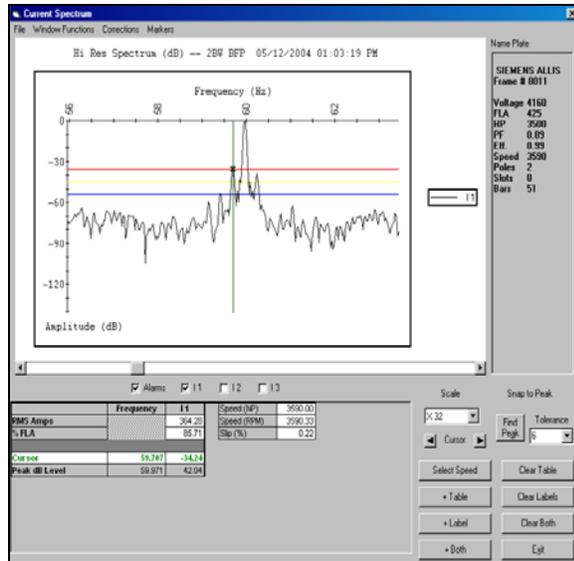
Figure 3

The Current Spectrum (Figure 3) of test data taken on 5/12/2004 showed an increase in sideband activity around the fundamental frequency, which also indicated broken rotor bars.

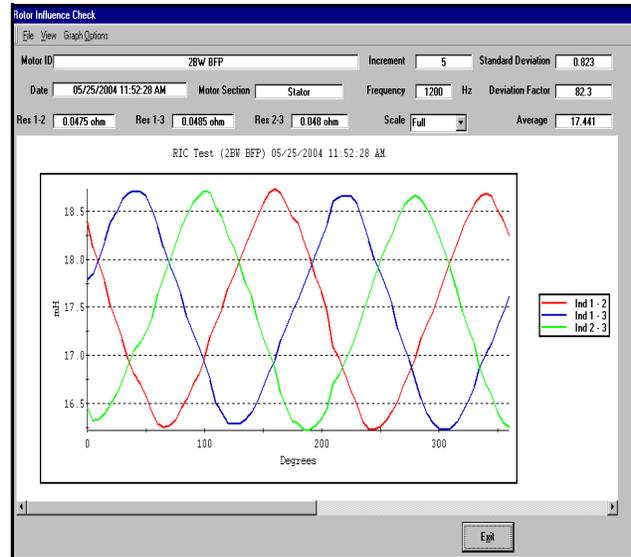
Figure 4

All EMAX test results indicated broken rotor bars in the motor. The motor was pulled and a RIC test was performed, which also indicated a rotor anomaly (Figure 4). The motor was sent to the motor shop, where it was disassembled. A visual inspection found 22 of 51 rotor bars were broken or cracked (See Figure 5).

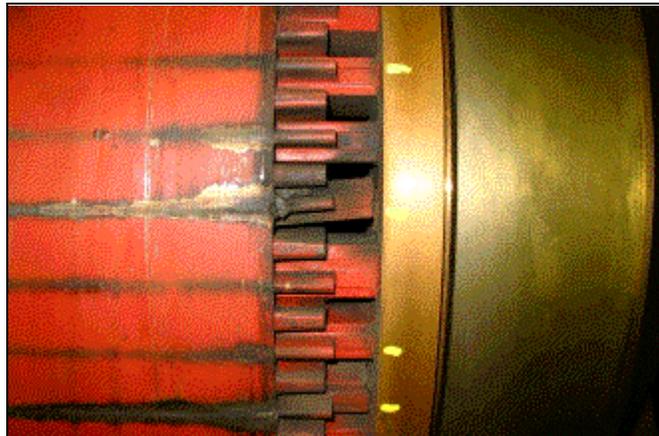
Figure 5

It was determined that bad braze joints between the bars and end rings from a rotor repair performed in 2001 caused the broken and cracked rotor bars.
