CASE STUDIES IN ONLINE AND OFFLINE MOTOR ANALYSIS

David L. McKinnon, PdMA Corporation, *Member, IEEE*

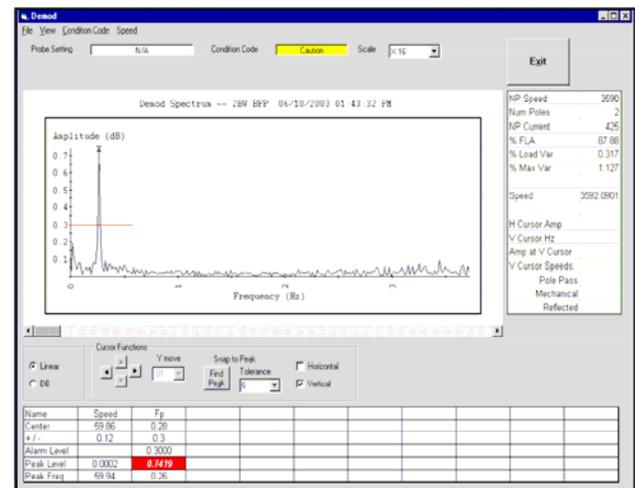
During routine EMAX testing in June 2003, it was observed that the peak dB level of the pole pass sideband was 0.7419 dB, which exceeded the alarm set point of 0.3 dB (Figure 1). Rotor bar problems were suspected, however, when vibration analysis was performed the results indicated a healthy motor. Due to the conflicting indications between the EMAX and vibration tests, the decision was made to monitor the motor and trend the test results.

Figure 1 – Demodulated Current Spectrum showing the Pole Pass Sideband at 0.7419 dB.

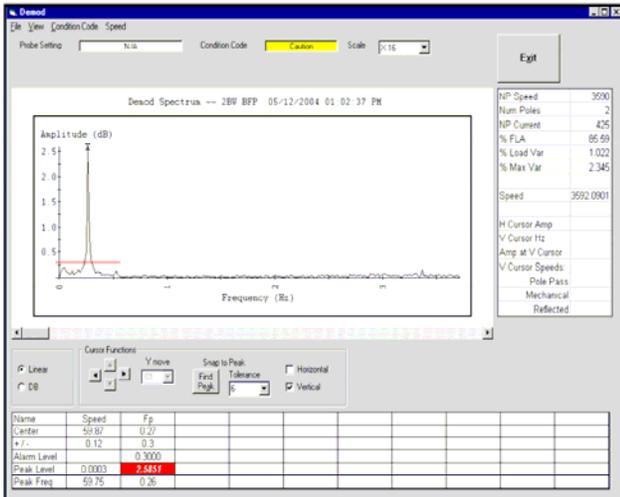
The motor was retested periodically until 5/12/2004, at that time it was removed from service. The trended data indicated a 1420% increase in the peak level of the pole pass sideband from 0.1814 dB at a running speed of 3591 RPM on 8/15/2001 to 2.5851 dB at a running speed of 3592 RPM on 5/12/2004 (Figure 2). Trending the data from tests taken between 2001 and 2004 showed an exponential increase in the pole pass peak levels, which is typically indicative of at least one or more broken rotor bars. Additionally, there was a 275% increase in the load variation, from 0.855% in 2001 to 2.345% on 5/12/2004 (Figure 2). The load variation should be constant from test to test under normal operating and motor conditions. The Current Spectrum (Figure 3) of test data taken on 5/12/2004 showed an increase in sideband activity around the fundamental frequency, which also indicated broken rotor bars.

Figure 2 – Pole pass sideband of 2.5851 dB at a running speed of 3592 RPM.

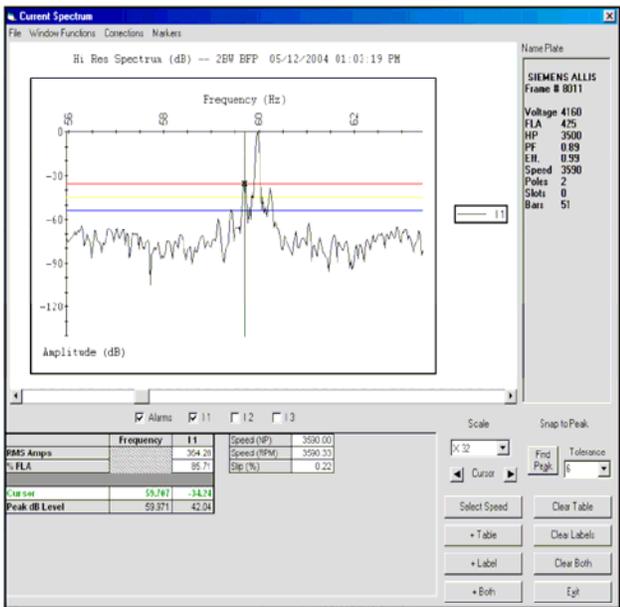
Figure 3 – Hi Resolution Current Signature Spectrum centered around line frequency.

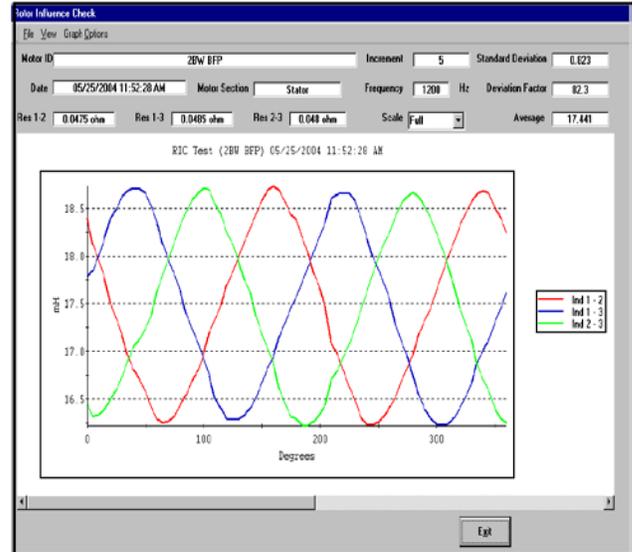
All EMAX test results indicated broken rotor bars in the motor. The motor was pulled and a RIC test was performed, which also indicated a rotor anomaly (Figure 4). The motor was sent to the motor shop, where it was disassembled. A visual inspection found 22 of 51 rotor bars were broken or cracked (See Figure 5).

Figure 4 – Rotor Influence Check (RIC) test of the motor before disassembly. Notice the repeated variations in the inductance waveforms, which are indicative of broken rotor bars.

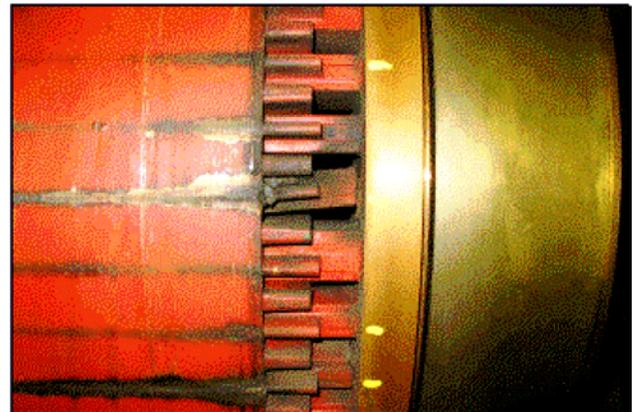
Figure 5 – Some of the broken rotor bars found using online and offline tests.

It was determined that bad braze joints between the bars and end rings from a rotor repair performed in 2001 caused the broken and cracked rotor bars.

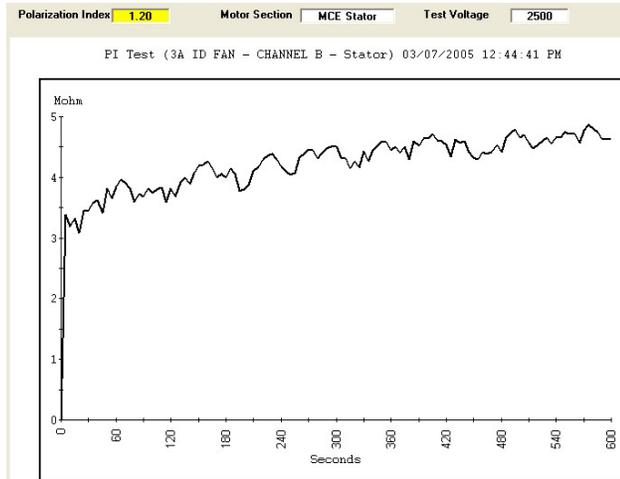
In March 2005, a PIP test was performed on an Induced Draft (ID) fan motor resulting in the PIP shown in Figure 6. Notice the low PI value and fast initial rise-time of the resistance to a relatively low value overall. These are indicative of an insulation system containing a significant amount of moisture. IEEE 43-2000 recommends an insulation resistance of no less than 100 Megohms and a PI value of >2.0 for this motor.

Figure 6 – Polarization Index Profile (PIP) of an insulation system containing a significant amount of moisture.

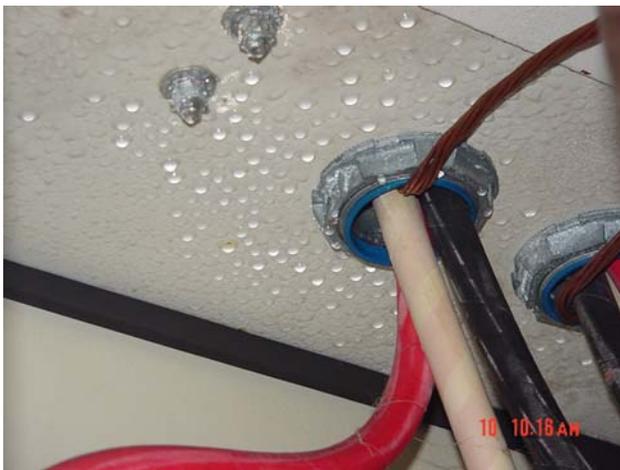
Figure 7 shows the moisture around the power cable entrance that caused the low overall PIP and low PI value.

Figure 7 – Condition that caused the unacceptable PIP.

The moisture was dried from all cables, components, etc., and another PIP performed a few days later. Figure 8 shows the resulting PIP after the dry-out. This PIP is indicative of a motor with a healthy insulation system.

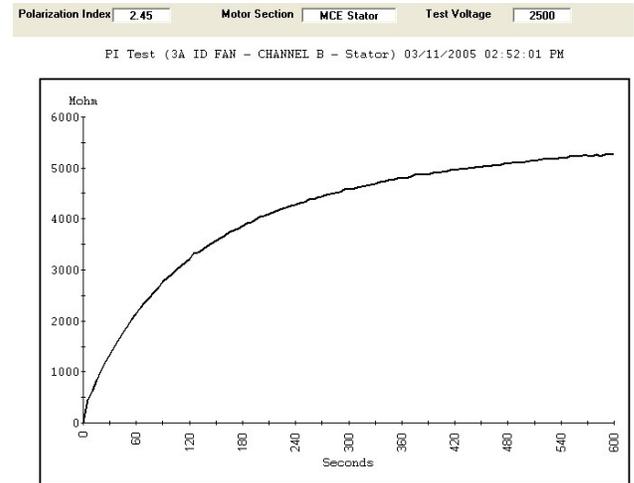
Figure 8 – Polarization Index Profile of a healthy insulation system.

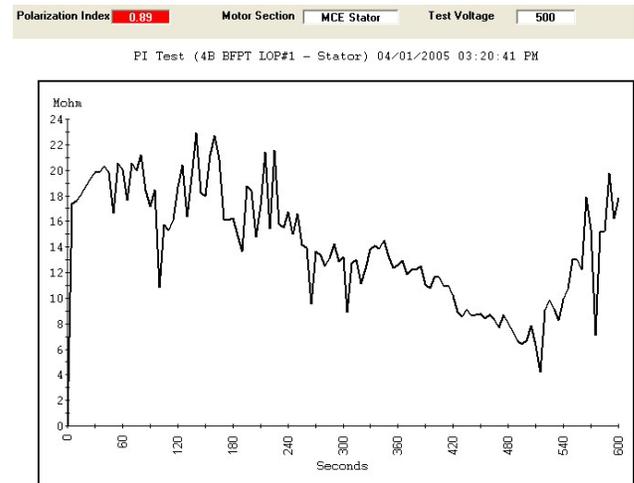
When insulation systems become contaminated with debris such as dirt, carbon dust, etc., the PIP will have a significant amount of spiking in the profile throughout the test as shown in Figure 9.

Figure 9 – PIP of a motor that has a contaminated insulation system.

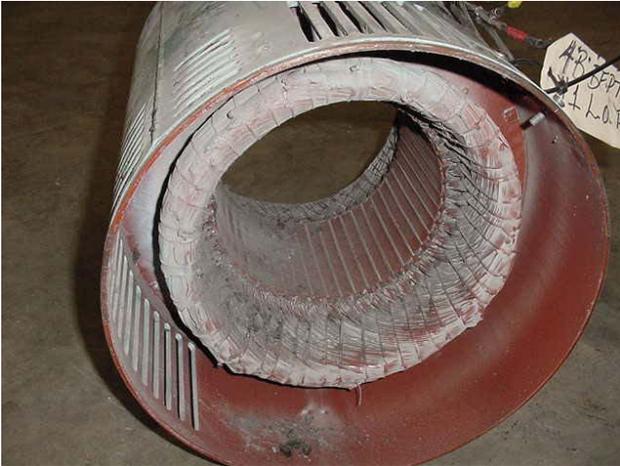
Figure 10 shows the contamination on the stator windings of the motor.

Figure 10 – Stator of the motor containing the contaminated insulation system.

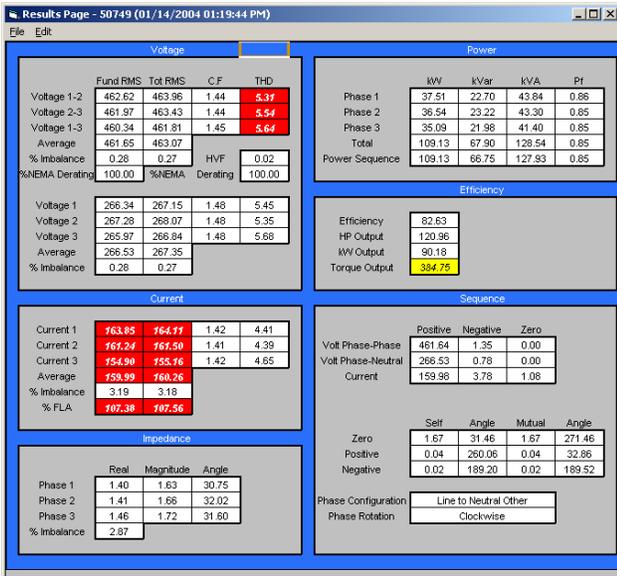
Initial test data on a winder motor indicated the voltage harmonics are greater than 5% and Full Load Amps (FLA) at 107% as seen in Figure 11.

Figure 11 – Test results page with the winder running.

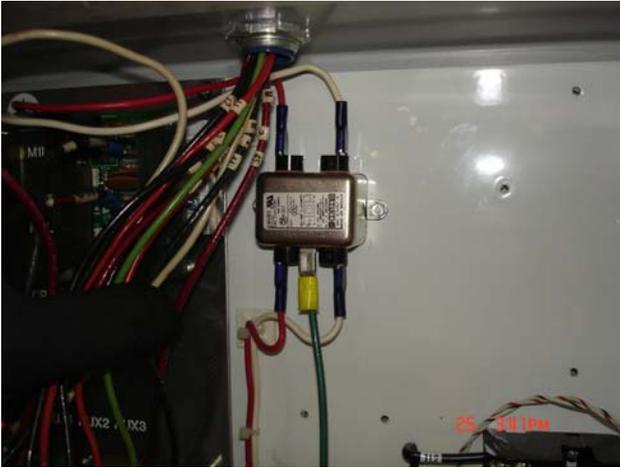
Figure13 – Line filters installed on a new controller.

After a review of the report, line filters were installed on all of the new controllers as shown in Figure 13. The problem for the dock lock controller disappeared.
