# CASE STUDY #9151

Industry:	Utility	Fault Zone:	Rotor
Motor:	Induction	Location:	MCC
HP:	200	Voltage:	4160
FLA:	275	Speed:	1175

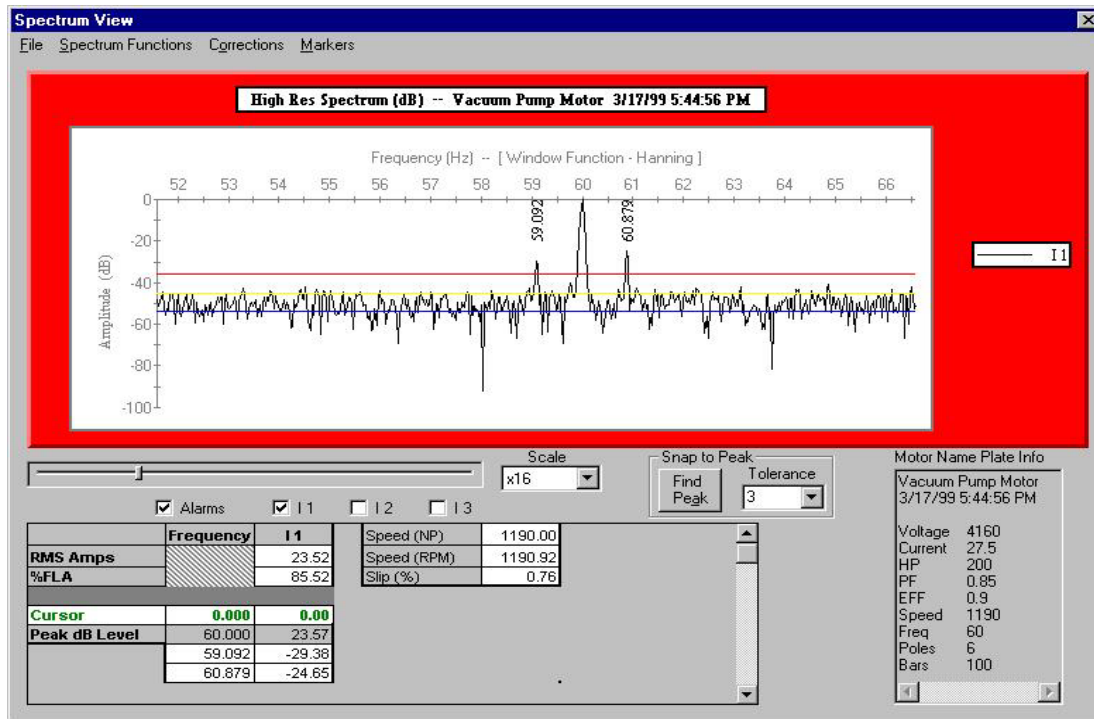
Current analysis testing revealed high sidebands at pole pass frequency with a 29 db differential from the 60 Hz peak. These results indicated the presence of a defective rotor, likely with multiple broken bars. The motor was removed from service and sent to a motor shop for evaluation. Upon inspection, a total of 8 rotor bars were found to be cracked or broken. The heat generated from the rotor defects had severely damaged the stator insulation. The decision was made to rewind the stator and repair the rotor at a cost of \$13,000.
