Multi-Technology Fault Identification

By: Reggie Fett, MCA/IR Analyst

Industry: Food and Beverage **Technology:** On-line MCA (Initially)

Component: Motor **Part:** Electrical Connections

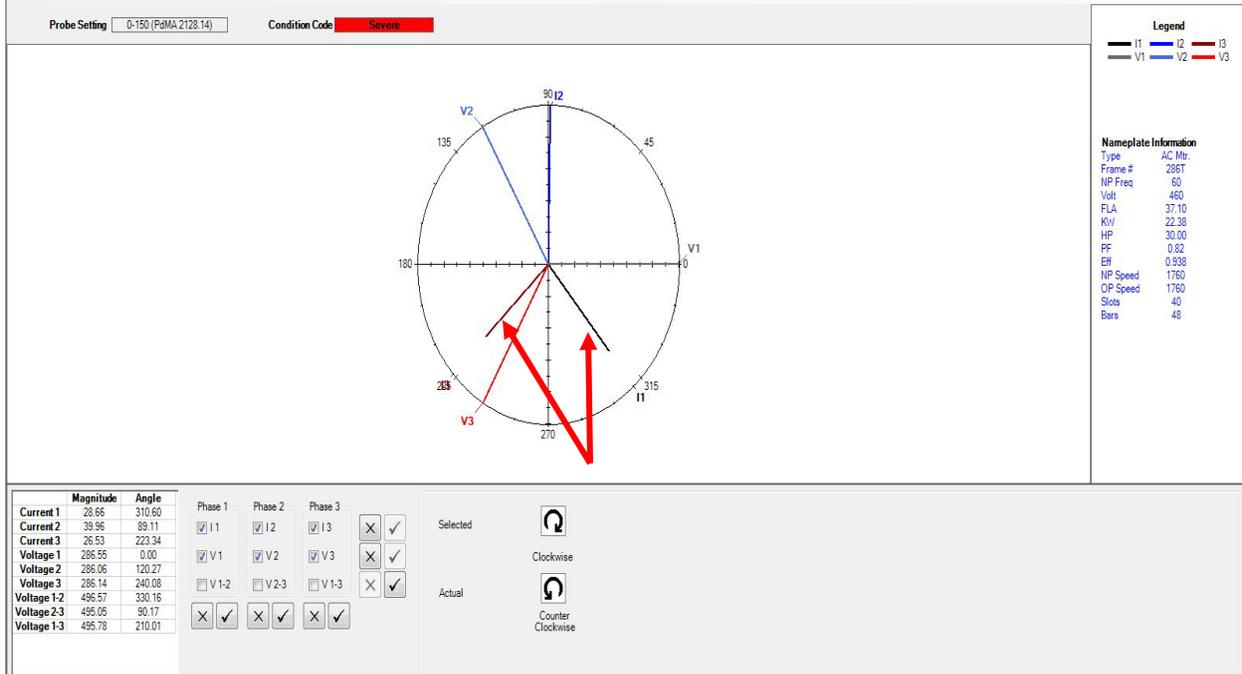
During routine on-line (energized) motor circuit data collection, test results indicated a 26.5% current imbalance, along with a 35.36% impedance imbalance. Looking at Figure 1, the Power Phasor shows the current imbalance indicated by the shorter current 1 and current 3 lines. Figure 2 shows the imbalance in the current section of the power test results page. Figure 3 is the Current Time Domain showing current 2 higher than currents 1 and 3. Voltage was checked and found to be balanced across the motor starter at 283 VAC phase-to-neutral and 490 VAC phase-to-phase.

Figure 1: Power Phasor Shows Both Current 1 and Current 3 Lower Than Current 2

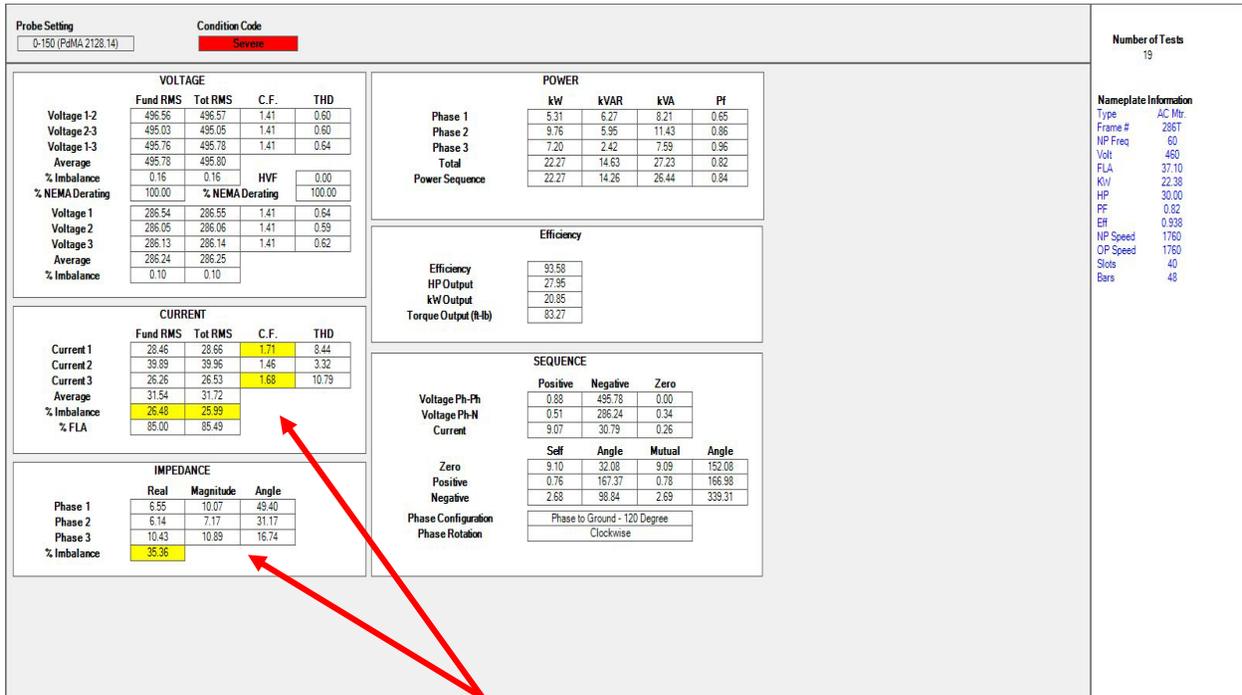
Figure 2: Power Test Results Showing the Current and Impedance Imbalances

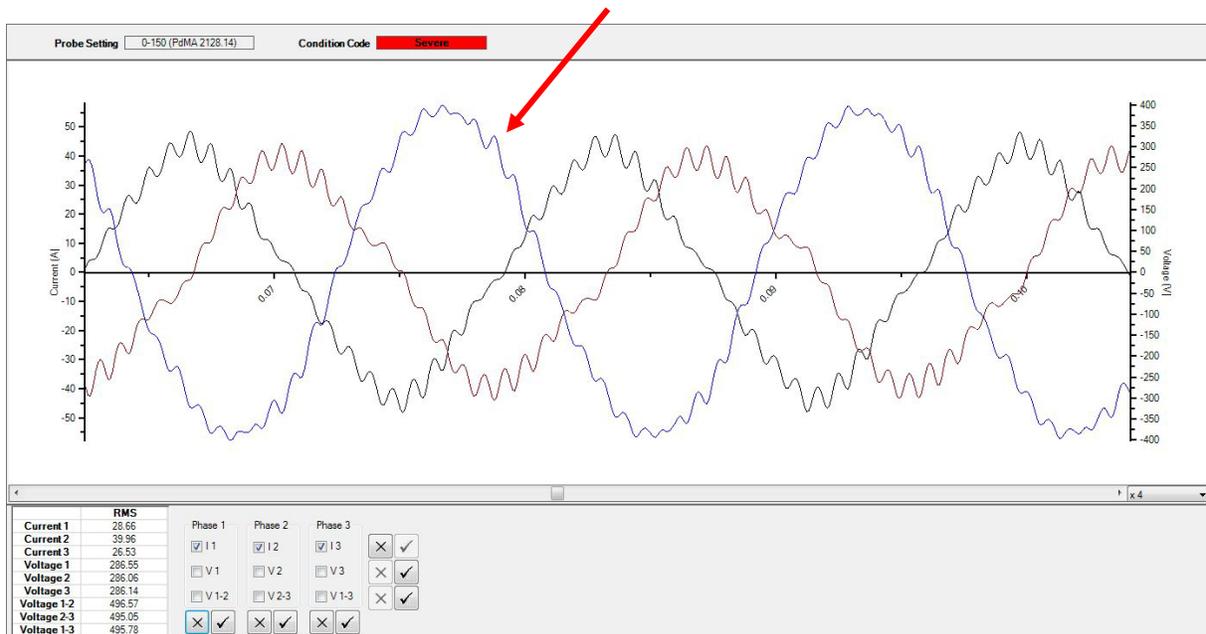
Figure 3: Current Time Domain Showing Current Imbalance

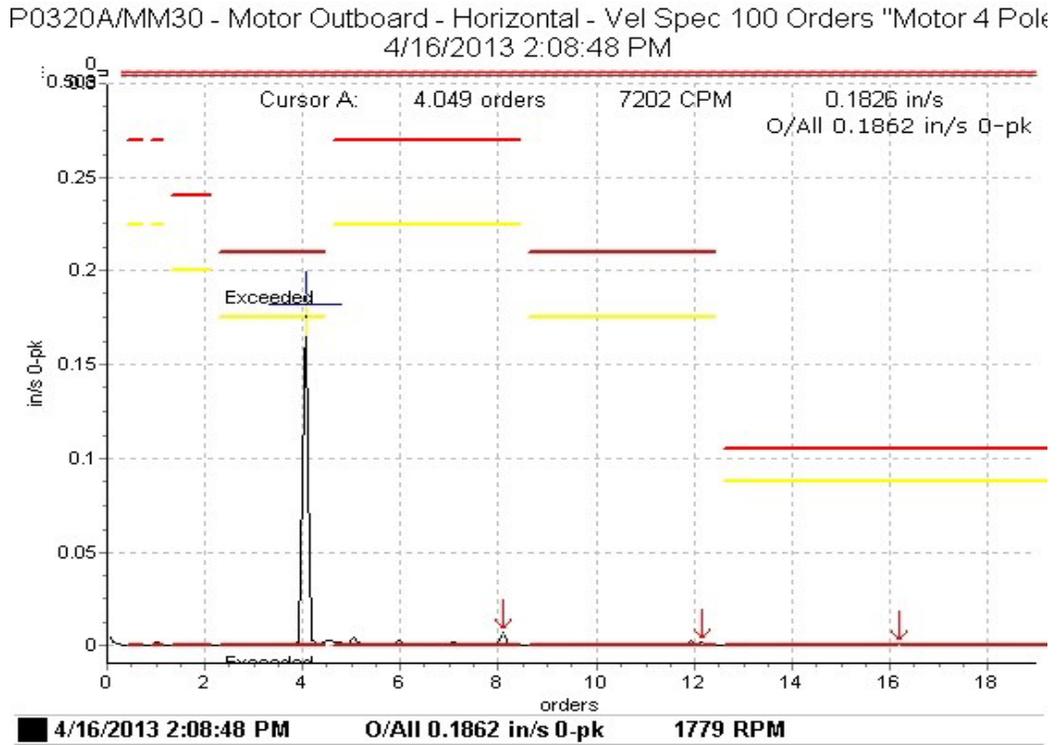
Vibration data was collected and found the motor was in alarm for a 2x line electrical frequency, indicating there was a possible electrical issue (Figure 4). An infrared scan was conducted on the electrical enclosures containing the fuses and motor starter. The B phase fuse and connections on the motor starter were operating with an above alarm level temperature differential. A thermographic scan of the motor revealed that the housing was operating hotter than normal, indicating a possible issue within the circuit. Figure 5 is an infrared image taken of the motor soon after the current imbalance was discovered by the on-line test. It shows the motor temperature was running above normal at 215°F, caused by the current imbalance. Figures 6 & 7 are infrared images taken of the motor starter and fuses. The temperature differential of the B phase circuit is caused by the imbalance in the circuit due to the high resistance connection. A work order was written to perform an off-line (de-energized) motor test to isolate the cause of the imbalances.

Figure 4: Vibration Spectrum Showing 2x Line Electrical Frequency

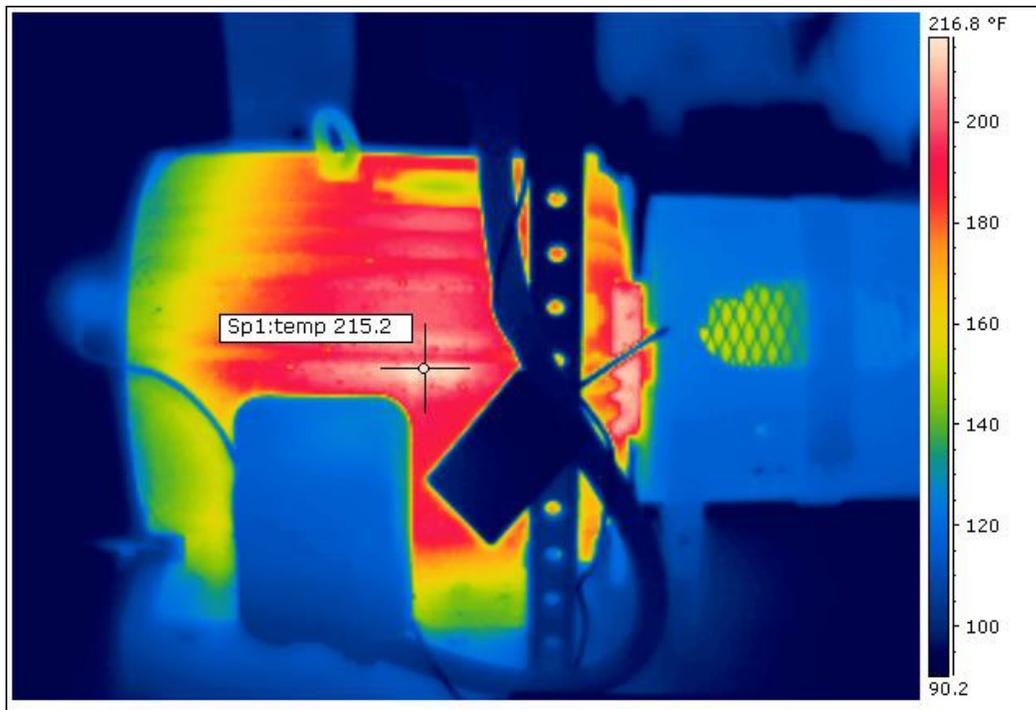
Figure 5: Infrared Image of Motor Indicating a Maximum Temperature of 215°F

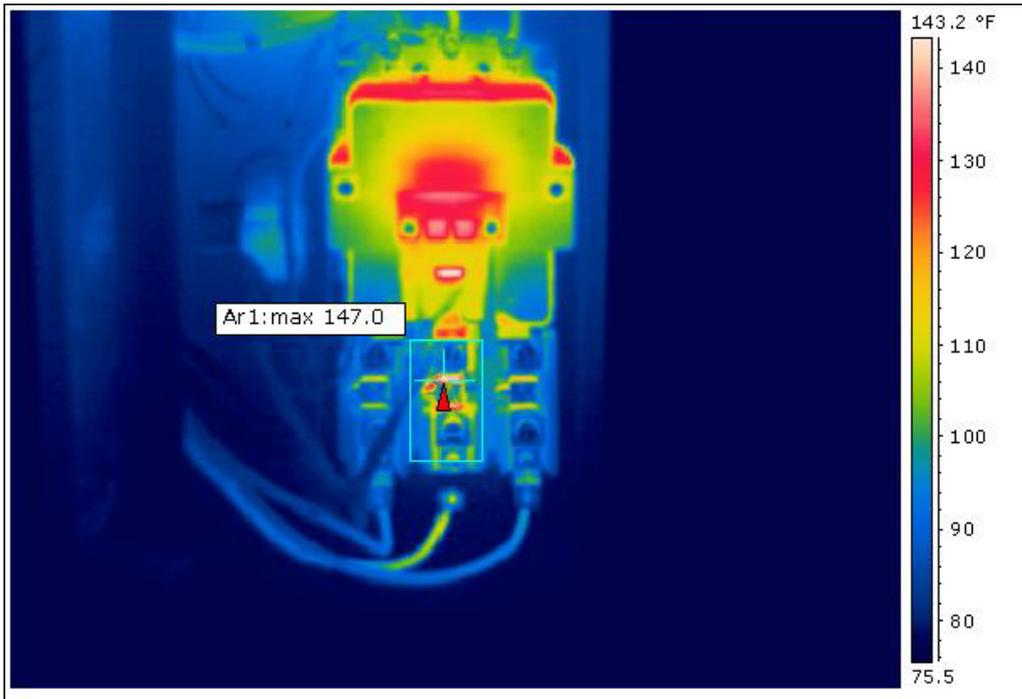
Figure 6: Infrared Image of Motor Starter Showing B Phase Connection at 147°F

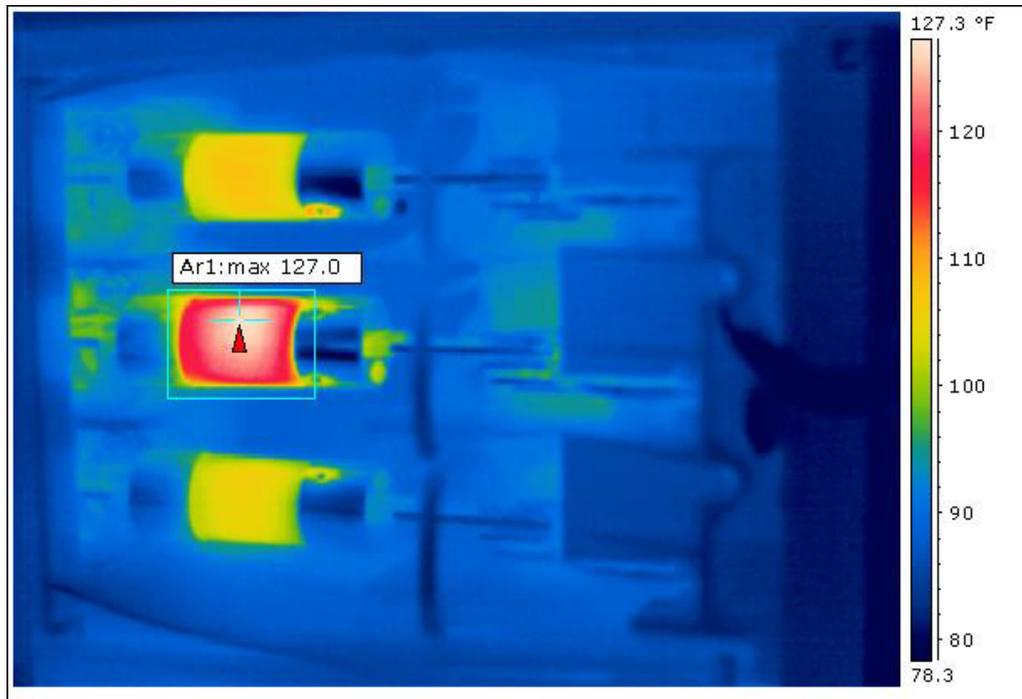
Figure 7: Infrared Image of Fuses Showing the B Phase Fuse at 127°F

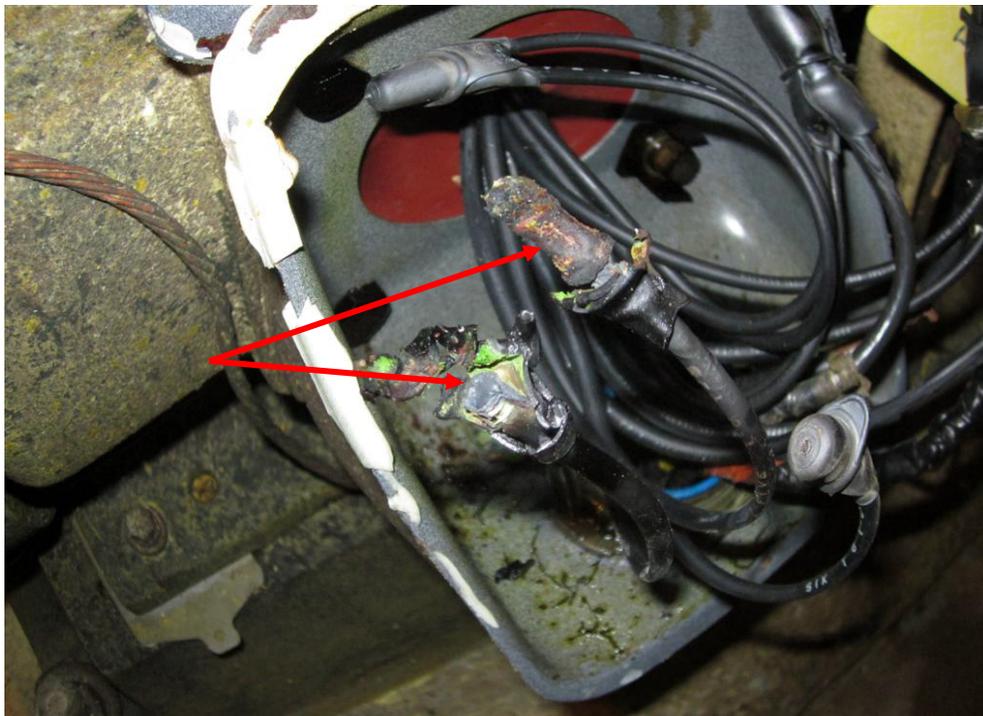
Figure 9: Image of Bad Connections Found After Opening the Motor Junction Box Cover

Not only is this type of condition shortening the life of the motor, but is also a potential hazard to personnel in the form of a shock hazard or burn hazard. If the connections were touching any part of the motor frame and the motor was not properly grounded, an individual who happened to touch the motor would become the least path of resistance to ground and could be seriously injured, suffering burns from the motor running hot, or worse, loss of life.

An off-line test was conducted from the Motor Control Center (MCC) and found a 44.65% phase-to-phase resistive imbalance, along with an 11.65% inductive imbalance. Figure 8 shows the phase-to-phase resistive imbalance and inductive imbalance from the off-line test conducted from the MCC indicating a high resistive connection in the circuit. It was decided that further testing should be done by going to the motor and disconnecting the motor from the circuit to further isolate the cause of the imbalances. Upon opening the motor junction box, a bad connection was discovered (Figure 9). All connections were repaired and another off-line test was conducted from the MCC, which indicated that the repairs had corrected the issue.
