Eastman Chemical Company Motor Analysis...Stepping out of the Box

By: Tom Whittemore, Jr., P.E.; Paul Aesque; and Danny Hawkins, Eastman Chemical Company

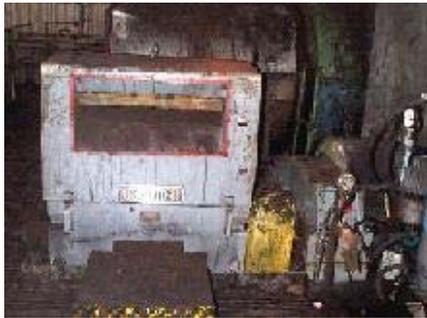
Figure 1- Gasification process rod mill, 800 HP motor, clutch and gearbox.

Rod mills are used to crush the coal used in our gasification process. The pinion gear transmits motor torque through the gear reducer to the rod mill's gear reducer (Figure 1). The motor is connected to the gearbox through a clutch, which uses an inert gas to engage the clutch disk. The clutch in turn is coupled to the gearbox, which in turn is coupled to the rod mill. The pinion's design life is five years minimum. Between 1997 and 1998, five pinions failed (Figure 2) between the two rod mills in our gasification process.

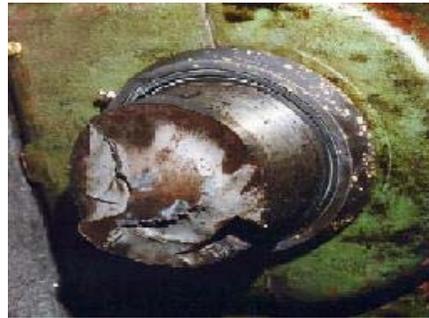
Figure 2- Rod mill pinion shaft failure.

A Root Cause Failure Analysis Team was formed to determine the root cause(s) of the pinion shaft failures. Several problems were identified that could be attributed to shorter than design pinion life. Some of these were:

- Too high of a rod charge level.
- Improper pressure switches that allowed the mill to be started with inadequate oil pressure.
- An inadequate startup procedure. The original procedure called for the mill to come to a complete stop before restarting it. The revised procedure did not include this statement. Operators had been trained using the revised procedure.
- The inert gas pressure in the clutch was too high.
- Improper clutch engagement time. The clutch manufacturer said the clutch should smoke 5-7 seconds to fully engage. Faster times will overload the pinion shaft and motor. The clutch is designed to be the wear part of the system, not the pinion shaft.

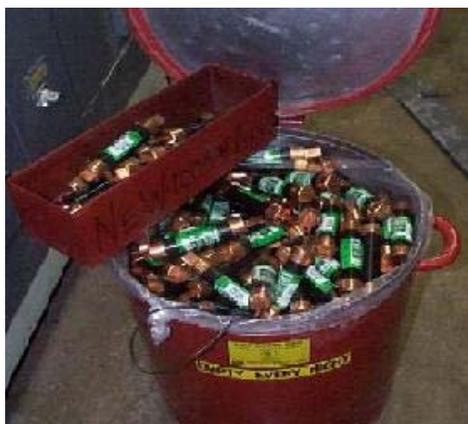
Figure 5- Failed 100 amp fuse graveyard for grinder motors.

We currently have six grinders in our B-255 Polymer process plant being driven by 50 HP, 480 Volt, 1800-rpm motor. The MAT was requested to evaluate the subject motors because four of these motors were blowing 100 amp fuses at an excessive rate of approximately once

per 12-hour shift (Figure 5). The CSM's were replacing all three 100 amp fuses at the motor starter when one would blow. This used more fuses, but resulted in fewer failures and less production losses.
