Motor Efficiency and Fault Zone Analysis

Noah Bethel, Vice President-Product Development, PdMA Corporation

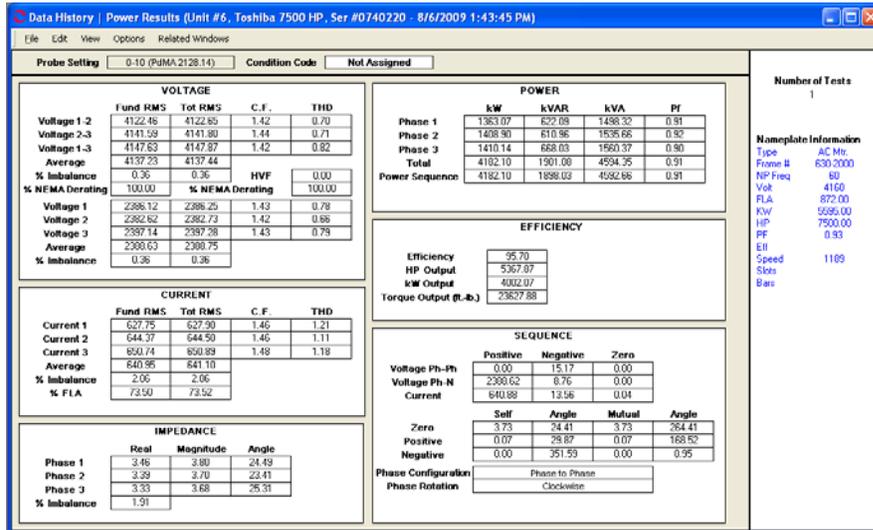
Figure 1

Data used to evaluate Power Quality is located in the phase-to-phase voltage section of the Results Page (Figure 1). Fundamental RMS, Total RMS, Crest Factor (CF), and Total Harmonic Distortion (THD) are listed for each of the phase-to-phase voltages. The average voltage and percent imbalance are also listed. Additionally, recommended NEMA derating factors are provided for both phase-to-phase voltage imbalance and Harmonic Voltage Factor (HVF).

PdMA’s MCEMAX Power Analysis test allows a technician to take a Power Quality snapshot in order to see the condition of the voltage signal and evaluate the effect it will have on the motor. The actual sample time for the simultaneous measurement of the three voltage and current phases takes less than one second. From this snapshot, the technician focuses primarily on the three phase-to-phase voltages that power the motor and determines what effect they are having on motor performance.

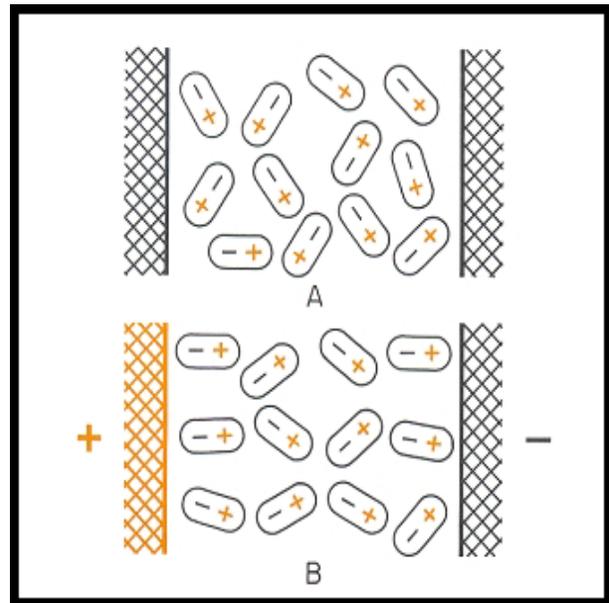
The **absorption current** is made of two components: the polarization of the insulation material and the second is due to the gradual drift of electrons and ions through the insulating material. The polarization current is caused by the reorientation of the insulating material. This material, usually epoxy, polyester, or asphalt tends to change the orientation of their molecules when in the presence of direct electric field. It normally takes a few minutes of applied voltage for the molecules to have been reoriented, and thus for the current-supplied polarizing energy to be reduced to almost zero. The absorption current, which is the second component, is the gradual drift of electrons and ions through the insulating material. These electron and ions drift until they become trapped at the mica surfaces usually found in rotating insulation systems. See Figure 2.

Section A of Figure 2 shows the random orientation of the insulation's molecules. As a direct voltage is applied via the MCE tester, the molecules start to polarize and align, see Section B of Figure 2. The energy required to align the molecules, and subsequently reduce the amount of escaping molecules, is known as absorption current.

Since absorption current is a property of the insulation material and the winding temperature, a specific absorption current is neither good nor bad. The absorption currents will vary from different insulating material. Prior to 1970, older thermoplastic materials used were typically asphalt or shellac which have a higher absorption current. After 1970, the shift was made to thermalsetting polyester or epoxy bonded insulating material, which significantly decreased the absorption current. Nonetheless, this doesn't mean that the more modern insulating materials are better because they have less absorption current.

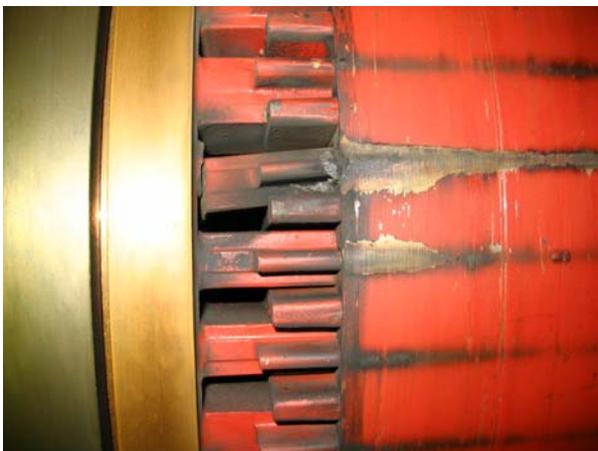
Figure 3

The design of the rotor plays a major role in the severity of an identified rotor anomaly. If the rotor is a closed bar design (Figure 3) the severity will be low due to the rotor iron acting to hold the broken rotor bar in place. However, if the rotor is an open bar design (Figure 4) then the severity increases significantly with the identification of a rotor defect. This elevated concern comes from the possibility of the rotor bar squeezing out of the rotor slot and contacting the stator.
