# CASE STUDY – STATOR

## RIC Diagnoses Stator Fault In New Motor

Industry: Cement  
Motor Type: AC Induction  
HP: 10

Fault Zone: Stator  
Volt: 460V  
RPM: 3495

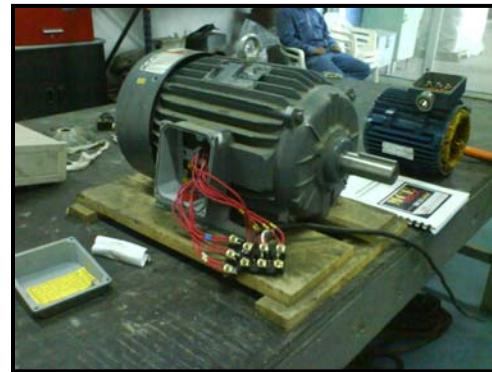
Therefore, that was the first test performed on this motor. Right away the RIC showed evidence of a stator fault. There was an obvious separation on the graph, showing phase 2-3 about 1.4mH lower than the other two phases. An AC Standard test followed the RIC. There was a 9.69%

Inductive Imbalance and a 0.34% Resistive Imbalance. Based on the results they were informed the motor was not in operational condition. It was decided to perform a test-run on the motor to verify its operation. The motor ran for about 35 seconds before going up in flames.

The MCEMAX provided an early warning of the critical stator fault. The Inductance graph on the RIC demonstrated what the usual resistance phase-to-phase readings missed.
