# CASE STUDY—STATOR

## MCEMAX Identifies Turn-to-Turn Faults

Industry:	Electric Utility	Fault Zone:	Stator
Motor Type:	AC Induction	Voltage:	4160
HP:	300	Speed:	590 rpm

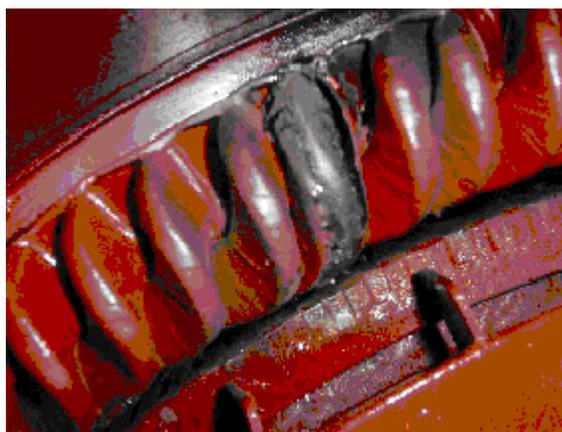
The motor shop disassembled the motor, pulled the rotor, and visually observed two turn-to-turn faults in the stator, shown in the picture on the right. The shop commented that this motor could have gone up in smoke the next time it was started. This plant has a predictive maintenance program that looks at conditions that can lead to stator faults. In this instance, using the MCEMAX tester they were able to detect a turn-to-turn fault with the motor energized.

The motor was scheduled for downtime and sent to a motor shop.
